**Barton under Needwood Parish Council
Barton Flood Risk Group**

Barton Brook - Surface water flooding 16-02-20.
Wales Lane, Collinson Road, Church Lane.
Plan BB-03 Rev A Drawn E Sharkey - 02-03-20

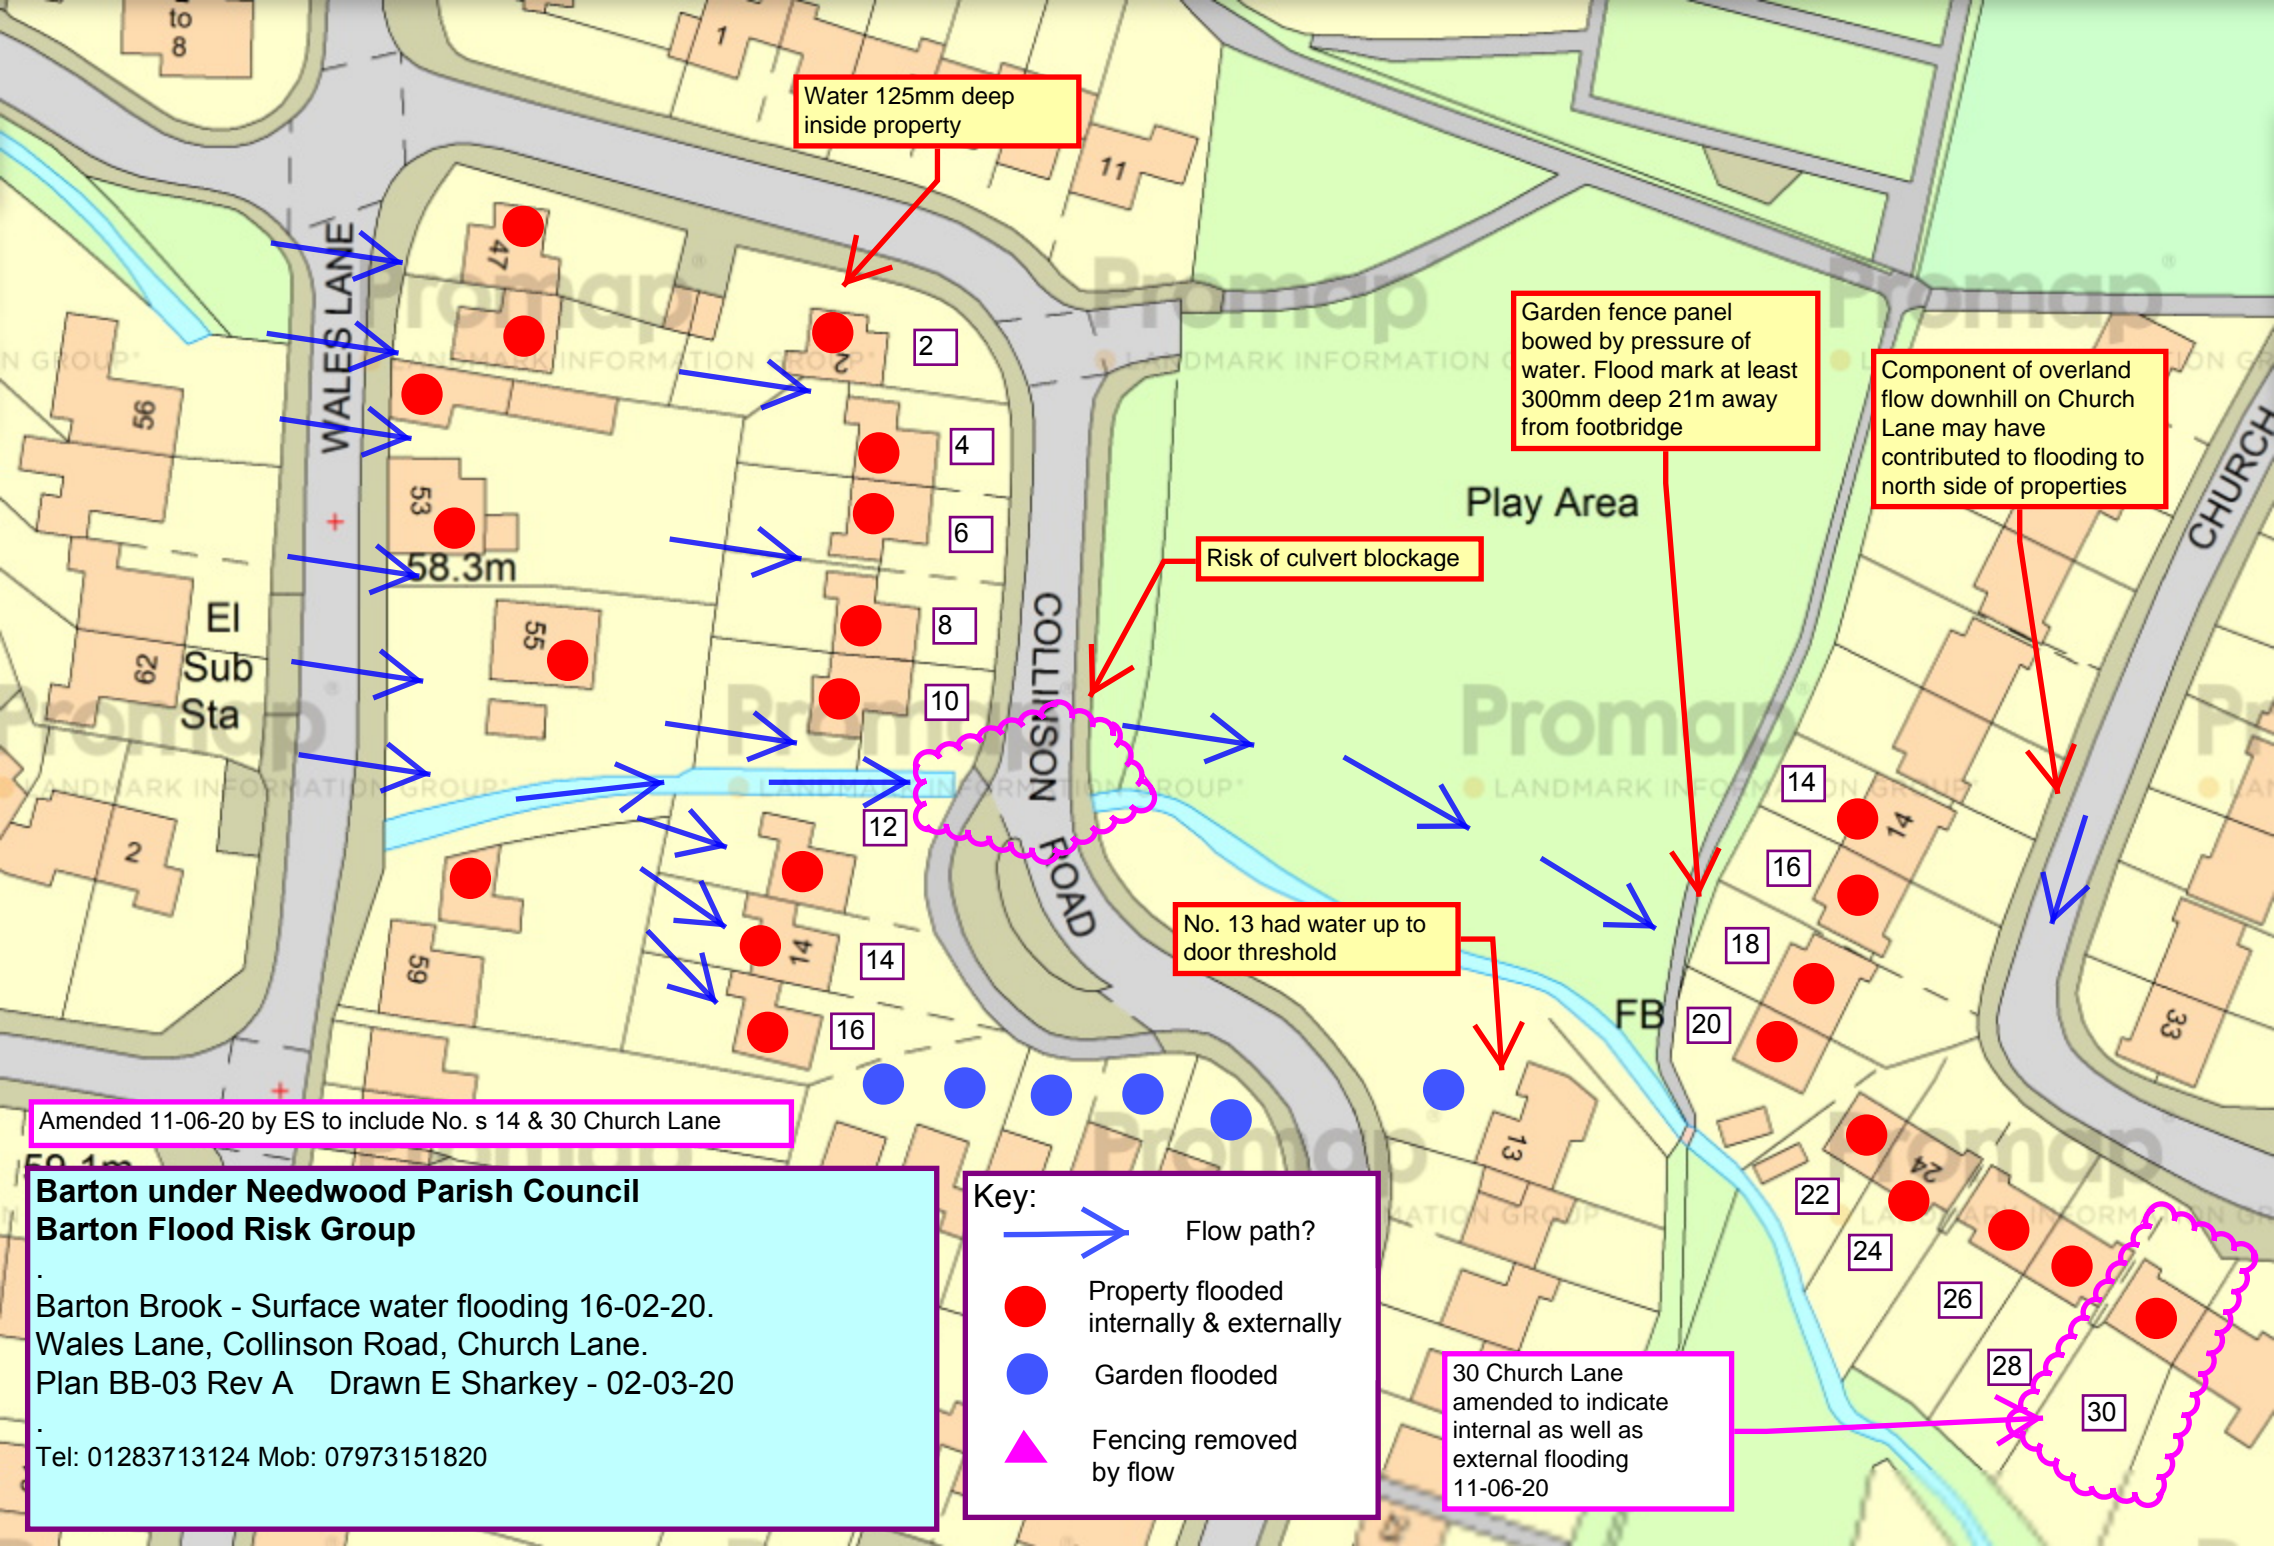
Water 125mm deep inside property

Garden fence panel bowed by pressure of water. Flood mark at least 300mm deep 21m away from footbridge

Component of overland flow downhill on Church Lane may have contributed to flooding to north side of properties

Risk of culvert blockage

No. 13 had water up to door threshold

Fencing removed by flow
